EXPERIMENTAL INVESTIGATIONS ON PARTICLE EROSION BEHAVIOR OF AA 6061 ALLOY

Karadeniz Technical University
Trabzon, Turkey

ABSTRACT

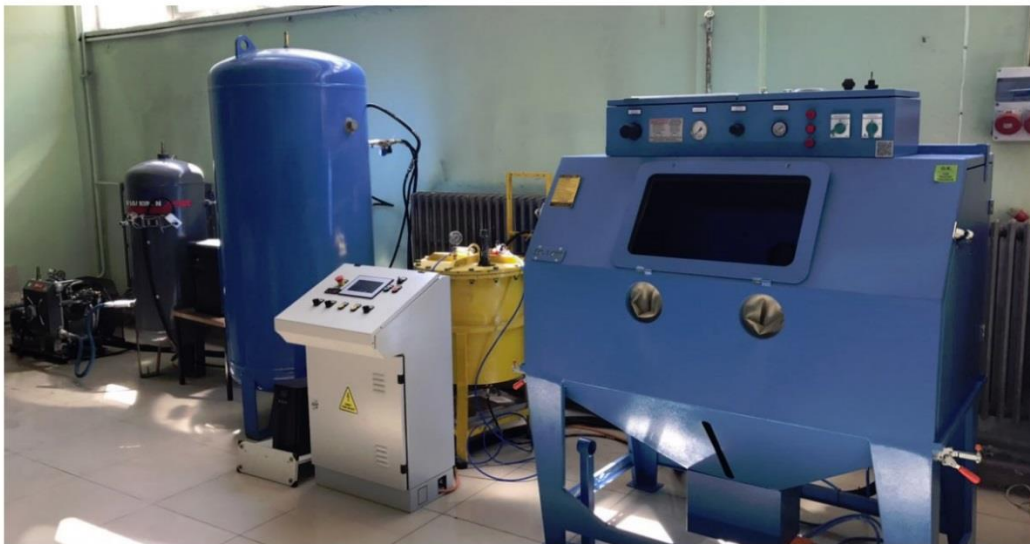
Schematic drawing and picture of developed test system is shown in Figure 1. The test system is composed of three main sections. The first section contains an air compressor with a pressure capacity of 40 bar and a reservoir tank for pressurized air. Second section includes a pressure conditioning tank and dust (erodent alumina particles) feeding system (Figure 2-a, b). In this section, the air is conditioned to the predetermined pressure values to achieve necessary velocities for erodents. In the last section, there is a test cabin covering linear moving platform actuated by a step motor. Test specimens are mounted on a platform which can move up, and down as well as left and right (Figure 2-c). Test system is capable of providing different impact angles and nozzle distances. Whole test system is controlled with control panel.

Figure 1. Solid particle erosion test system developed, a) Schematic of test system, b) Actual photo of test system

Solid particle erosion is one of the major reasons leading large financial losses and service interruptions in aviation industry. Gas turbines blades, fuel tanks, ammunition, compressors of helicopters and aircrafts are among the components affected by solid particle erosion. A structural part called *erosion shield* is used to minimize erosion in helicopter rotor blades. The major goal of this application is to minimize (prevent if possible) damage on composite structured main rotor blade, especially during take-off and landing. The standard erosion tests [e.g., ASTM G76-13, 2013; ASTM F1864-16, 2010] are not capable of reflecting the take-off, landing conditions, and therefore are not regarded as appropriate for testing erosion performance of erosion shields. Therefore, a dedicated testing method was developed and standardized [MIL-STD-3033, 2012]. According to this standard, erodent particles must be angular-shaped quartz sand within the dimension range of 240-550 µm while the impact velocity of erodent particles is recommended to be 225 ± 10.6 m/s (730 ± 30 ft/s). A test system that is capable of performing erosion tests per abovementioned standards was developed by authors within the scope of this study (Figure 1).

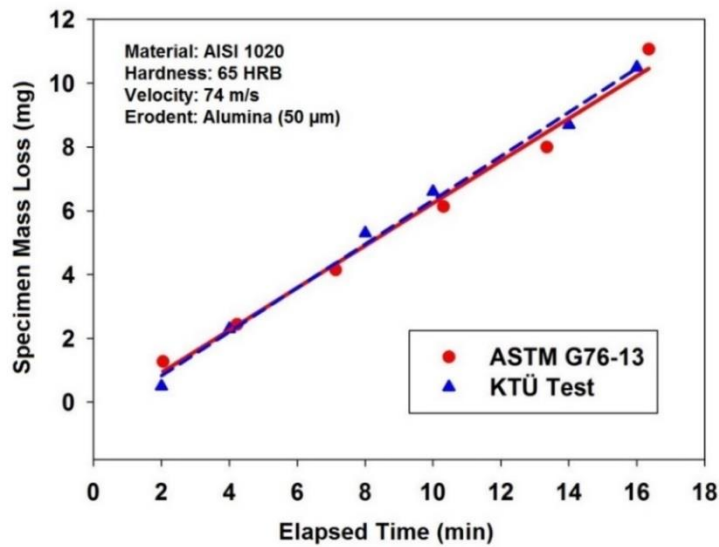
standard, and it was used for calibration purposes. Test results showed quite a well agreement with the ones reported in ASTM G76-13 (Figure 3). Following the calibration, erosion tests were carried out for AA 6061 aluminum alloy.

Figure 3. Comparison of erosion tests on AISI 1020 with ASTM G76-13 for calibration of solid particle erosion test system

The test system devised and constructed was first used to determine the wear performance of AISI 1020 steel per ASTM G76-13 standard. AISI 1020 is the reference material in the

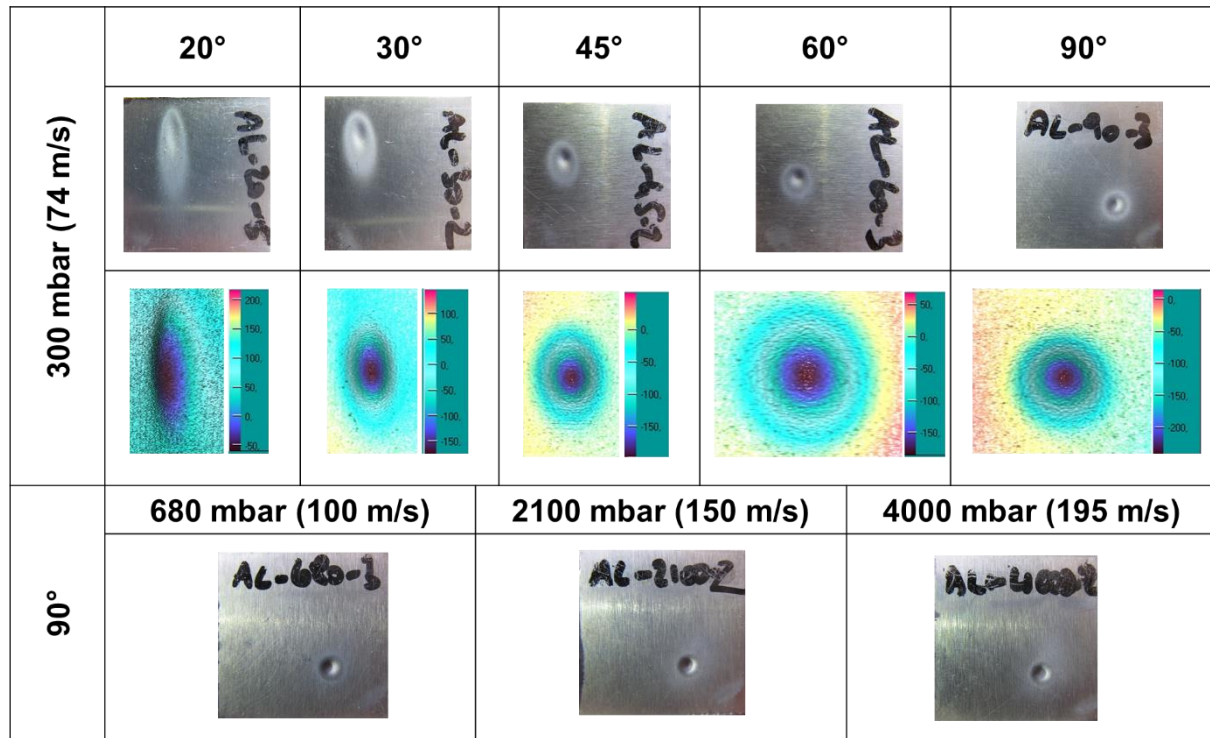
Figure 4 shows the tested samples and erosion crater and tracks observed at different impact angles and velocities. It is clearly seen that as the impact angle increases the wear scar in elliptical form converts to circular one (e.g. at 60° and 90°).

topology, as well as sectional profiles for craters were acquired. As it can be seen from Figure 4, the shape of the erosion crater turns into a circular structure from elliptical one as the impact angle increases. Besides, maximum depth value for craters increases with the increasing impact angle.

Figure 4. Erosion crater and tracks on tested specimens obtained at different impact angles and velocities

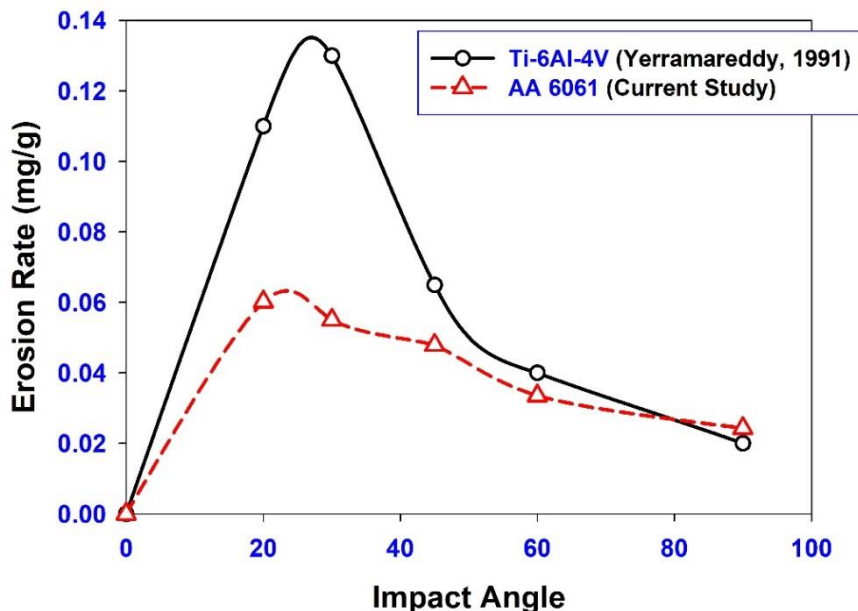
The results obtained in current study were also compared with the ones obtained by Yerramareddy and Bahadur. They tested Ti6-Al-4V alloy samples which were air cooled from 940°C using a horizontal sand-blast test rig [Yerramareddy and Bahadur, 1991]. In their tests, silicon carbide particles 125 µm in nominal dimensions (120 grit) were used as erodents. The impingement velocity of particles was set to 55 m/s. Even though the test conditions are not same with the current study, comparison of erosion rates with respect to impact angle is provided in Figure 6. It is observed that the erosion rates at oblique impact condition (90°) are quite close yet the maximum erosion rate for AA 6061 was almost half of the one obtained for Ti-6Al-4V. In addition, different from current study, maximum erosion rate was obtained at 30° for Ti-6Al-4V.

Figure 6. Comparison of erosion rate-impact angle behavior of AA 6061 and Ti-6Al-4V alloys

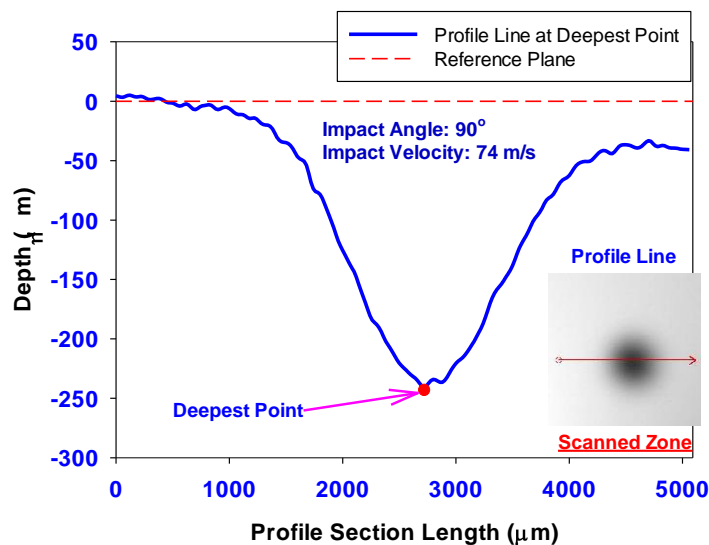
Worn surfaces were also scrutinized by means of non-contact laser profilometer. The section profile that passes through the deepest point of the crater was extracted for each sample. As an example, Figure 8 shows the section profile of the samples tested with 74 m/s impact velocity, and 20° impact angle. Comparison of maximum crater depths with respect to impact angle and velocity are provided in Figure 8. It was observed that crater depth increases with the increasing impact angle except for the 60° case. Maximum crater depth of 247 μm was obtained at 90° impact angle (Figure 8a). Effect of impact velocity on the crater depth comparison was based on the tests performed with at 90° impact angle (Figure 9-b). It is seen that up to 150 m/s, the crater depth increases with the increasing impact velocity whereas lower crater depth was obtained at impact velocity of 195 m/s. Even though it needs further investigation it is assumed that above certain impact velocity, the erodent particles hardens the surface (e.g. plastic deformation by compressive stress) rather than resulting in wear.

Figure 8. An example of section profile for specimen tested at 20° impact angle and 74 m/s impact velocity for its deepest point

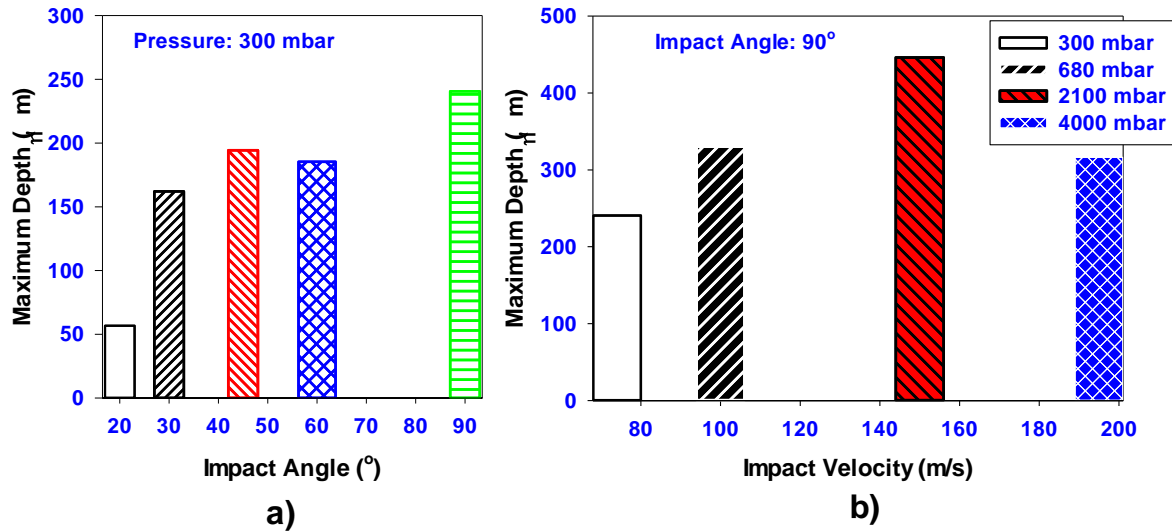
Figure 9. Surface scan results: Effect of impact angle, b) impact velocity on maximum depth occurred in the erosion crater
